PROJECT: Midnite Mine Remediation**REPORT NO:** 2021-14**OWNER:** Newmont/Dawn Mining**OPERATOR:** Newmont/Dawn Mining**SUMMARY OF WORK ACTIVITIES OR EVENTS FOR THIS REPORTING PERIOD:**

This weekly report provides a summary of Midnite Mine Site (Site) remediation action (RA) construction activities, quality assurance (CQA), quality control (CQC) and engineering activities for the period June 25 – July 1, 2021. The Site activities discussed in this weekly report include, but are not limited to: Site Health, Safety, and Security; Community Liaison, Project Meetings, Regulatory Oversight, Site Visitors; Site Mobilization; RA Activities; Project Documentation; and Site Inspections.

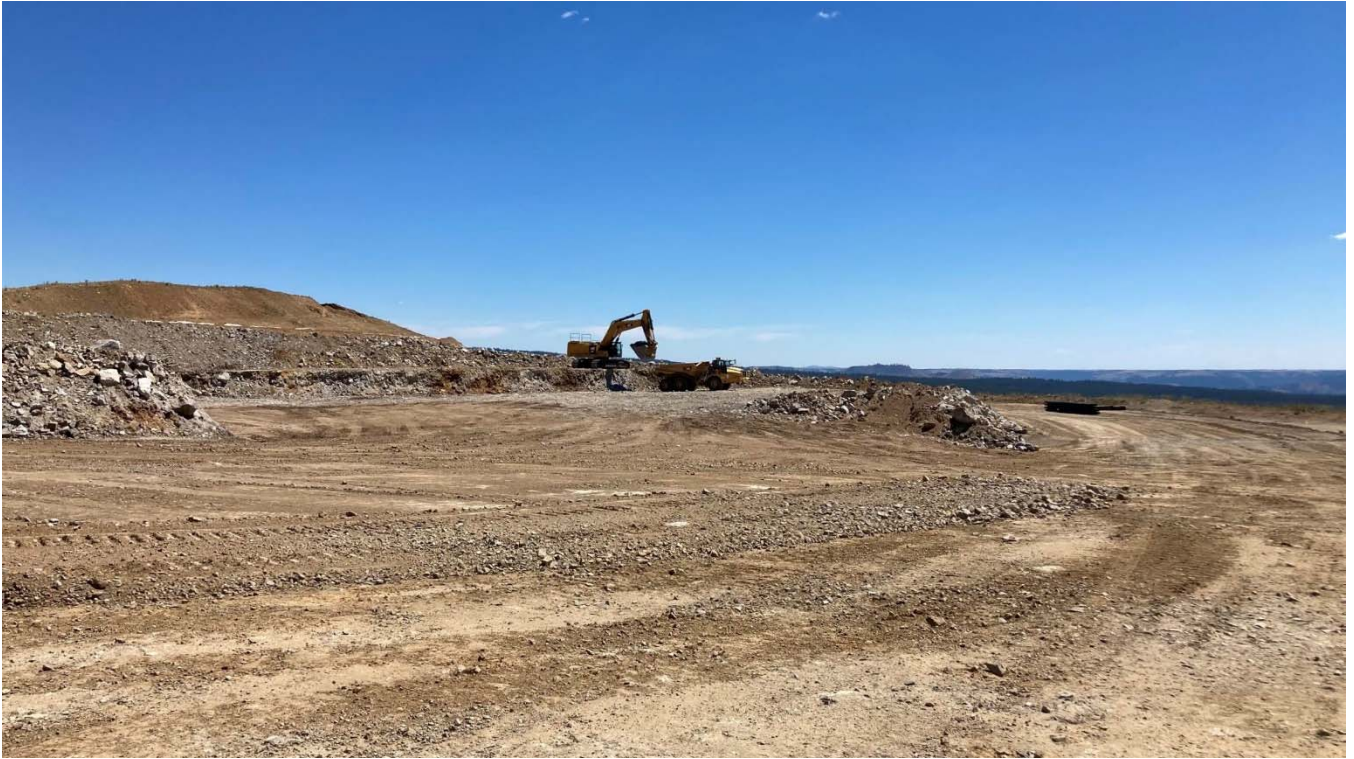
Figure 1 – Excavating, loading and hauling of low activity/low reactivity material from the South Waste Rock Pile – Mid.

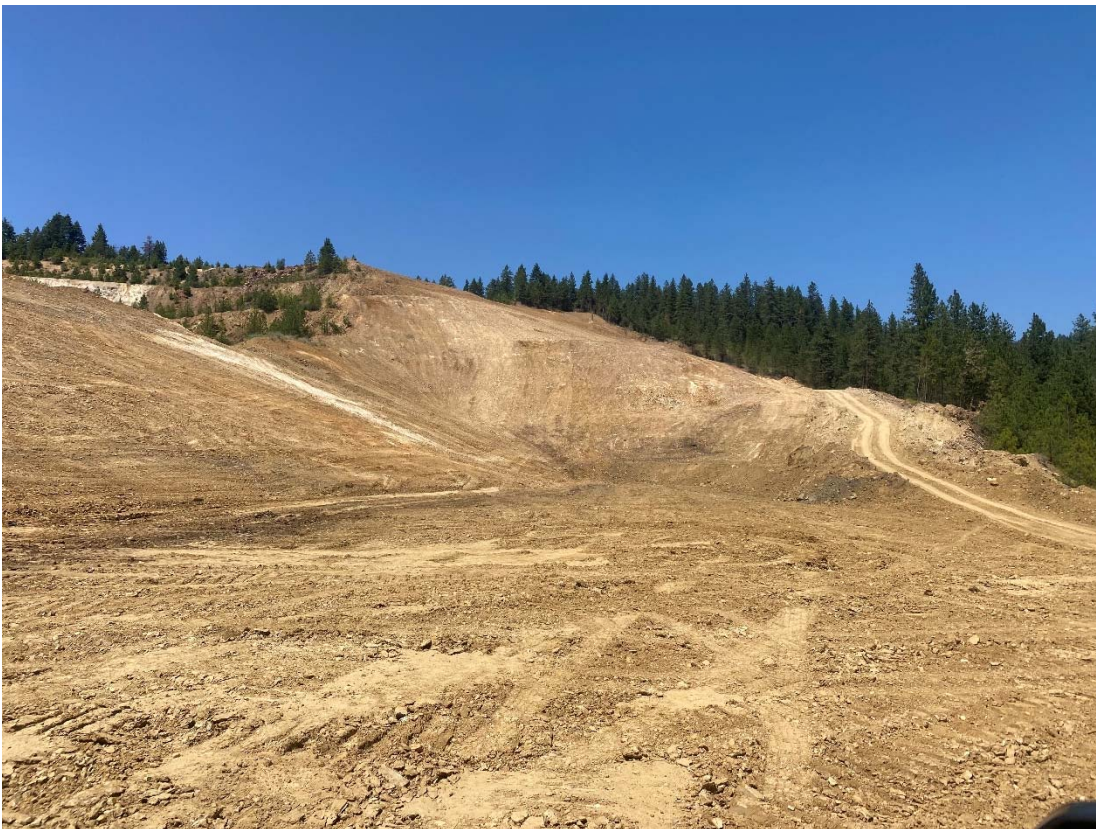
Figure 2 – Progress of excavation at the Pit 4 Overburden Pile.

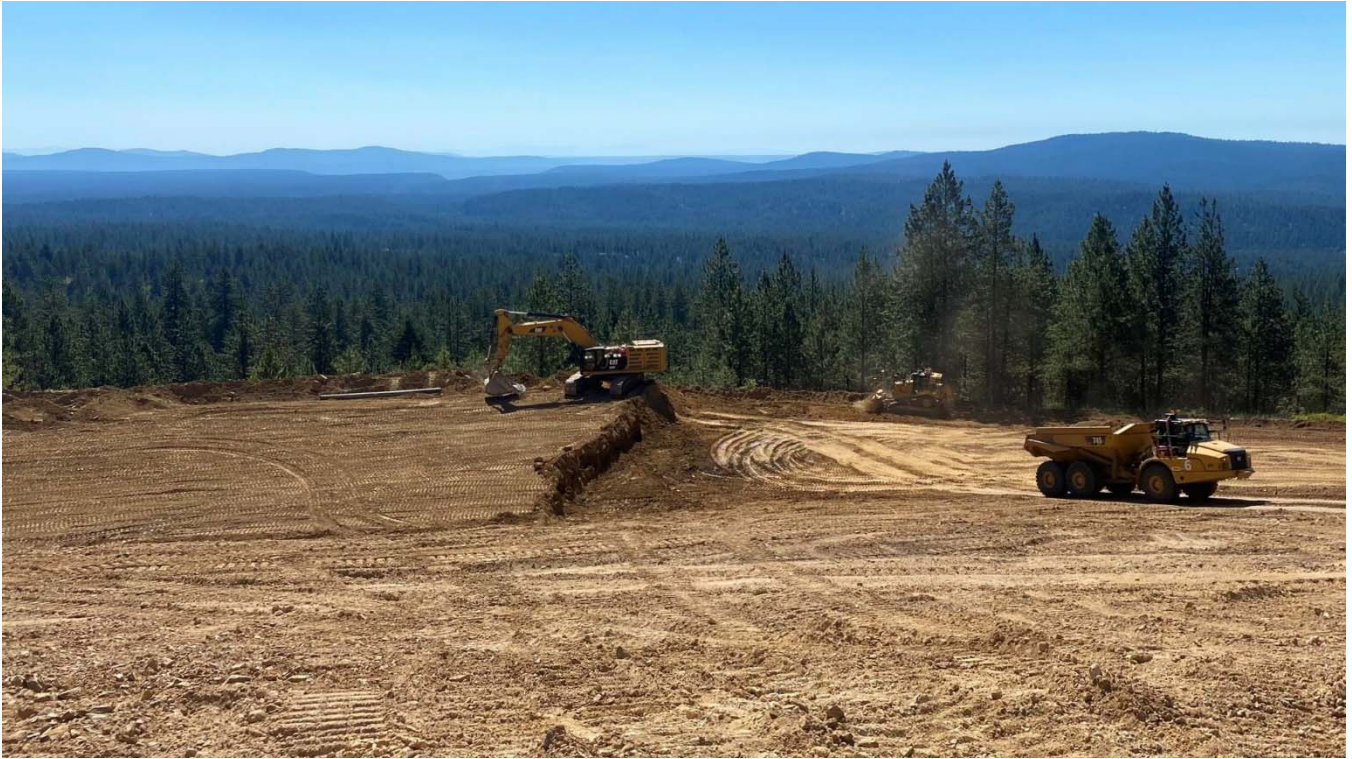
Figure 3 – Excavation, loading and hauling of low activity/low reactivity material from the Pit 4 Overburden, view looking east.

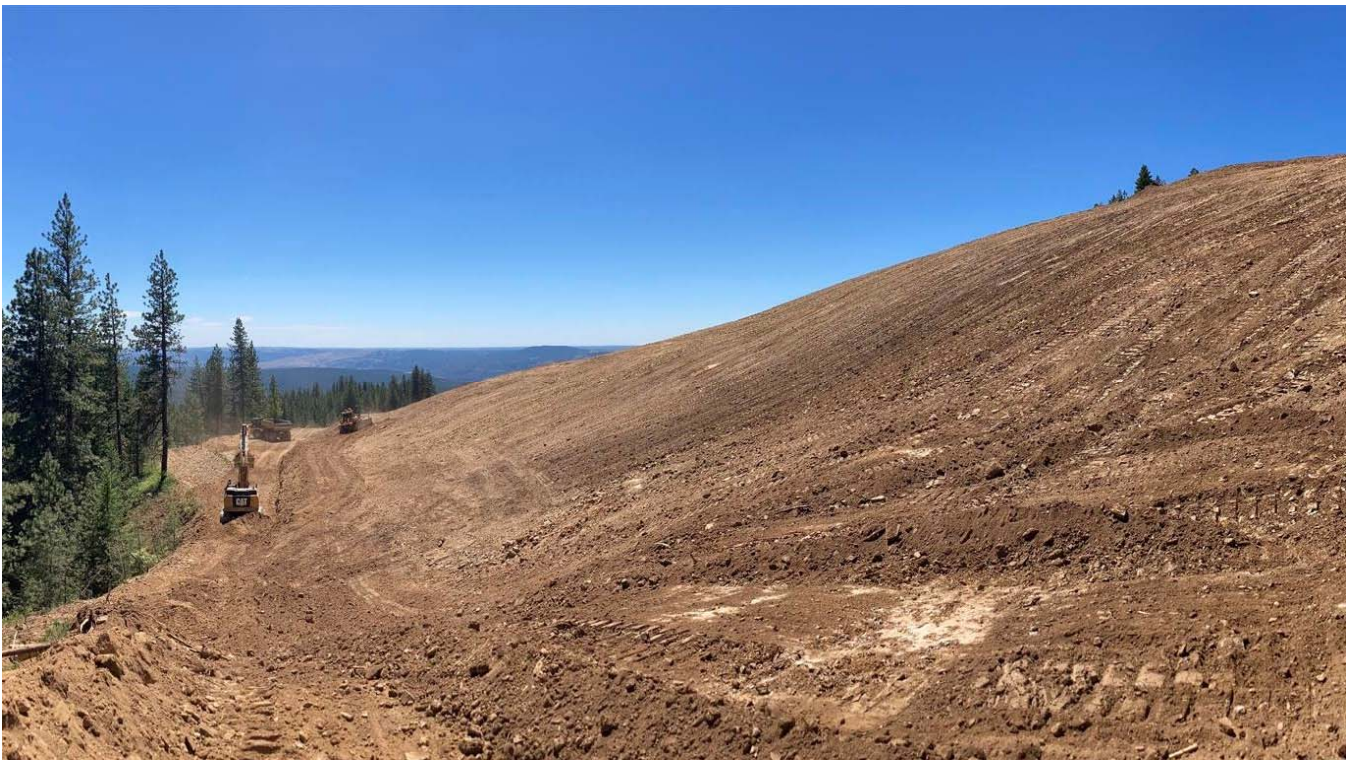
Figure 4 – Progress of surface grading at the Pit 4 Overburden.

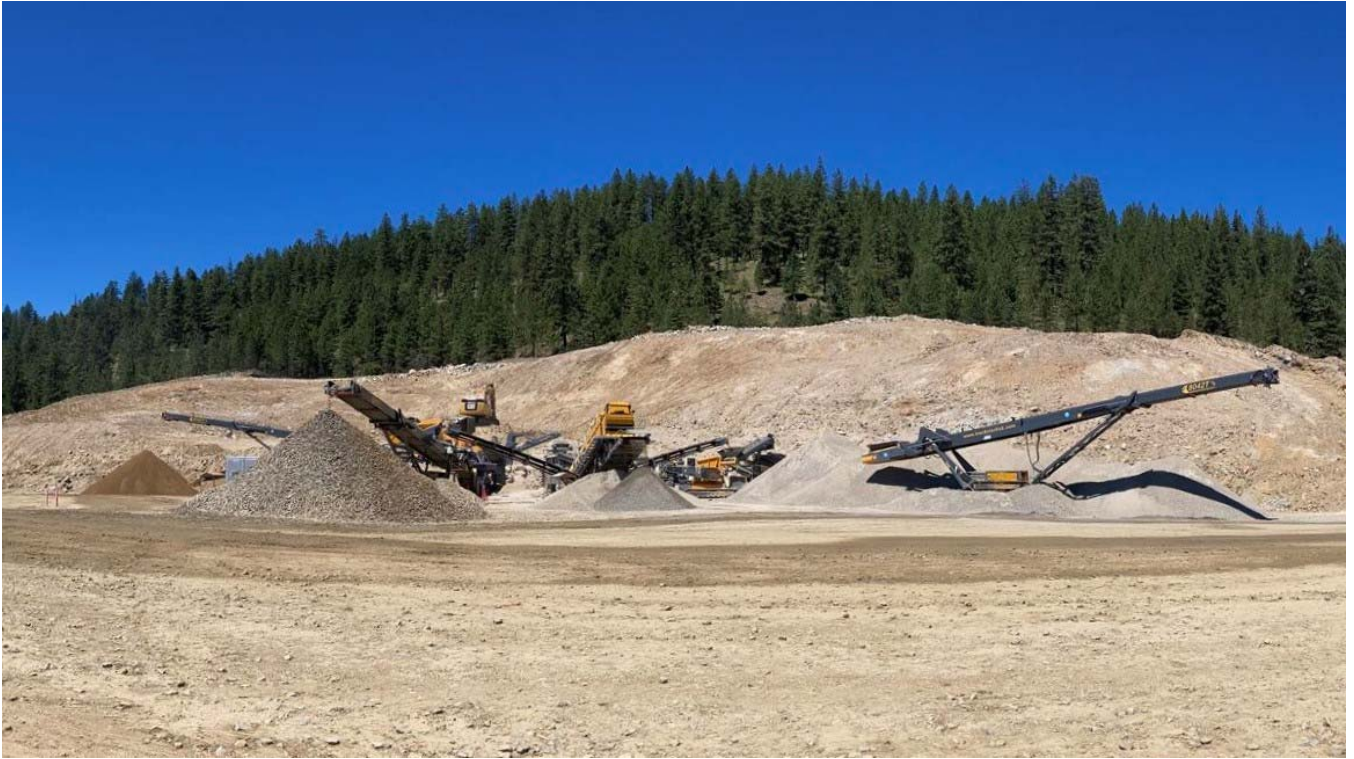
- SLV Earthmovers continued crushing and screening material from the Hillside Waste Rock Pile (HSWRP) to produce Drain Gravel, Liner Bedding and Geomembrane Bedding Material. Newmont hauled these materials to stockpile locations designated in the 2021 Crushing and Stockpiling Work Plan (Stantec, 2021). Estimated quantities of materials produced are presented in Table 1.

Figure 5 – Crushing and screening operations at the HSWRP.

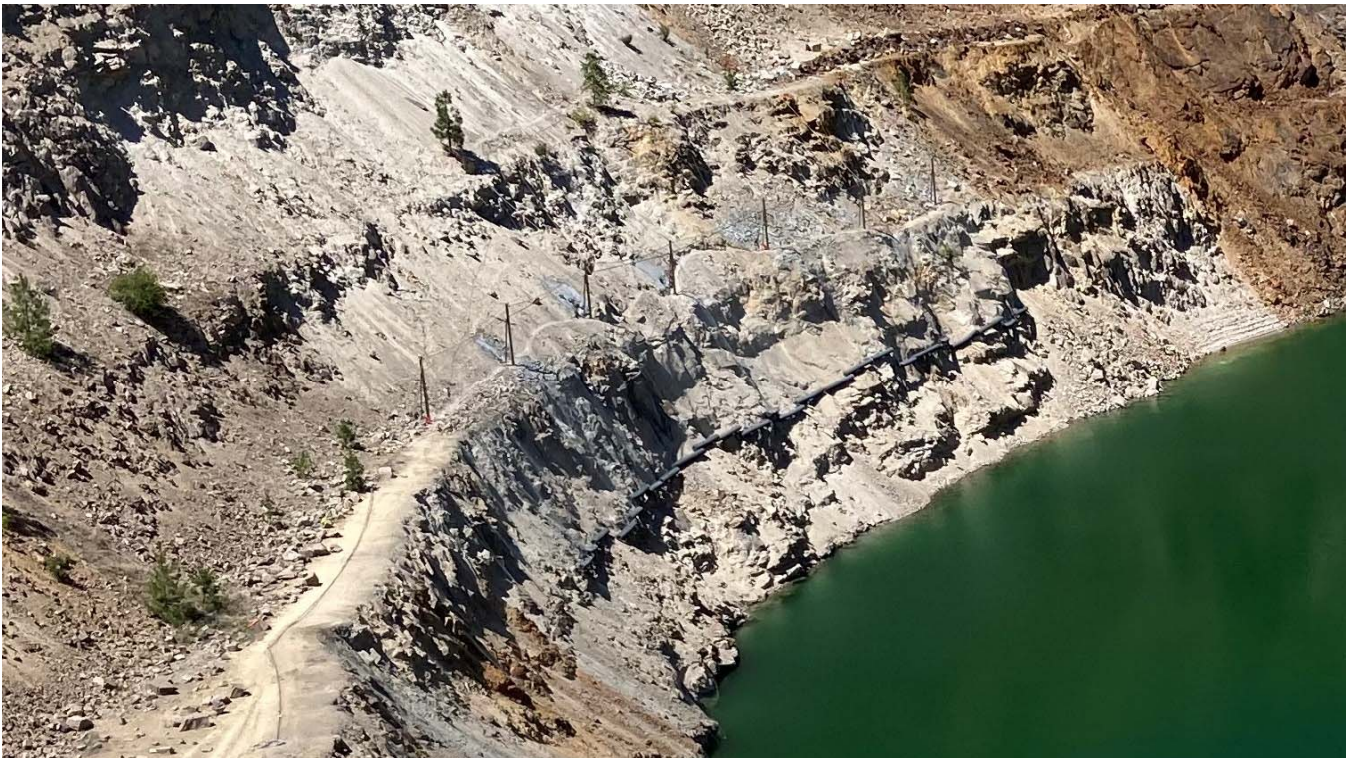
Figure 6 – Detail view of rockfall protection drape installed in Pit 3.

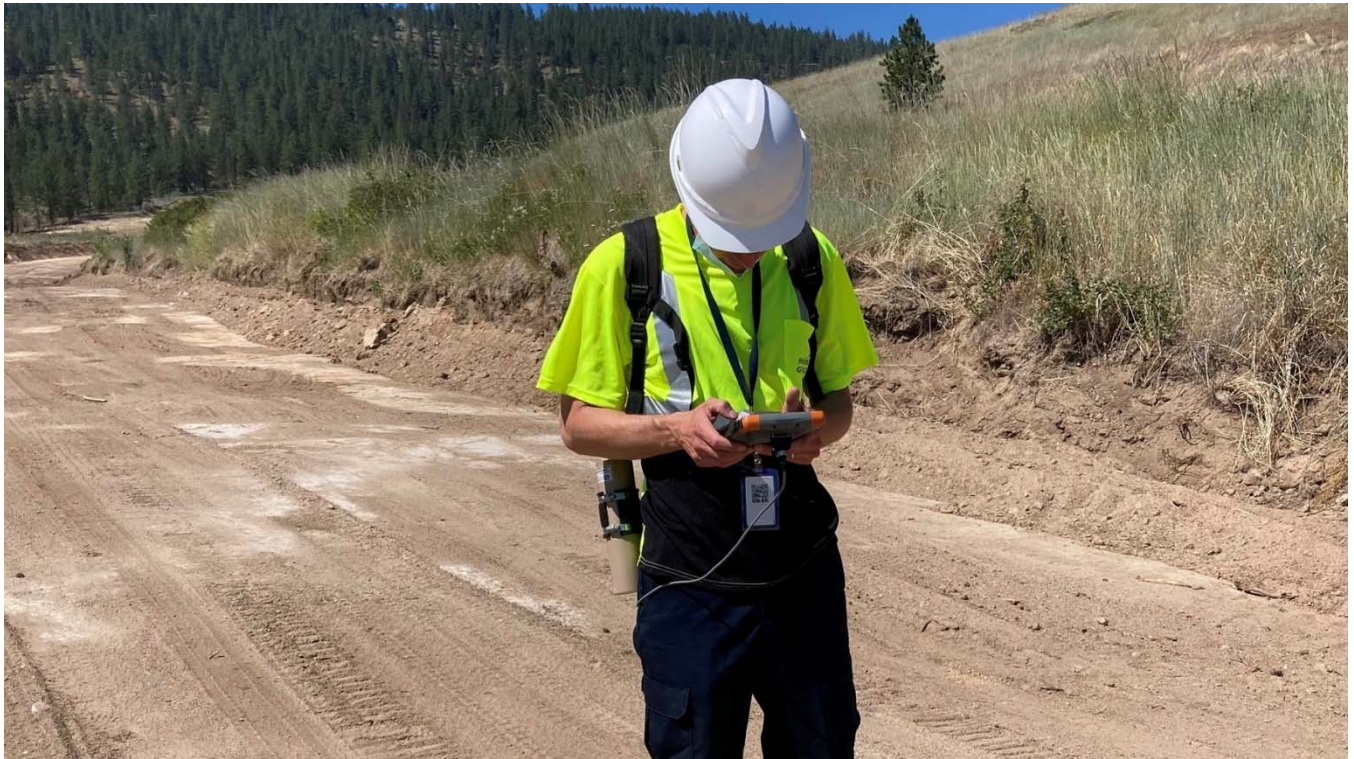
- Newmont extended the West Infiltration Collectors.
- WME and Nile Environmental performed the Final Status Survey gamma scan of the South Construction Support Zone on 26 June. CQC and CQA personnel confirmed that areas with elevated gamma levels are associated with bedrock and do not contain visible mine waste.

Figure 7 – Checking “hot spots” in the CSZ to verify that all visible mine waste had been removed in those locations.

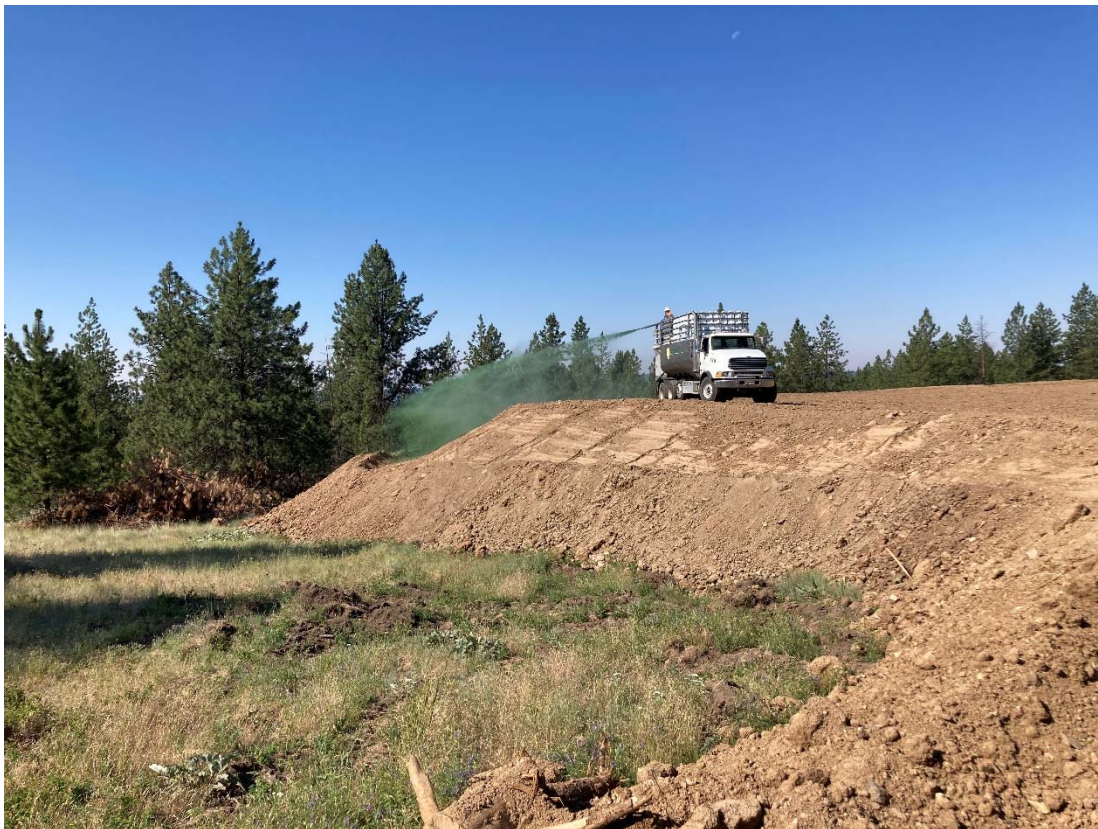
Figure 8 – SSEC-Apex hydroseeding the New Topsoil Pile.

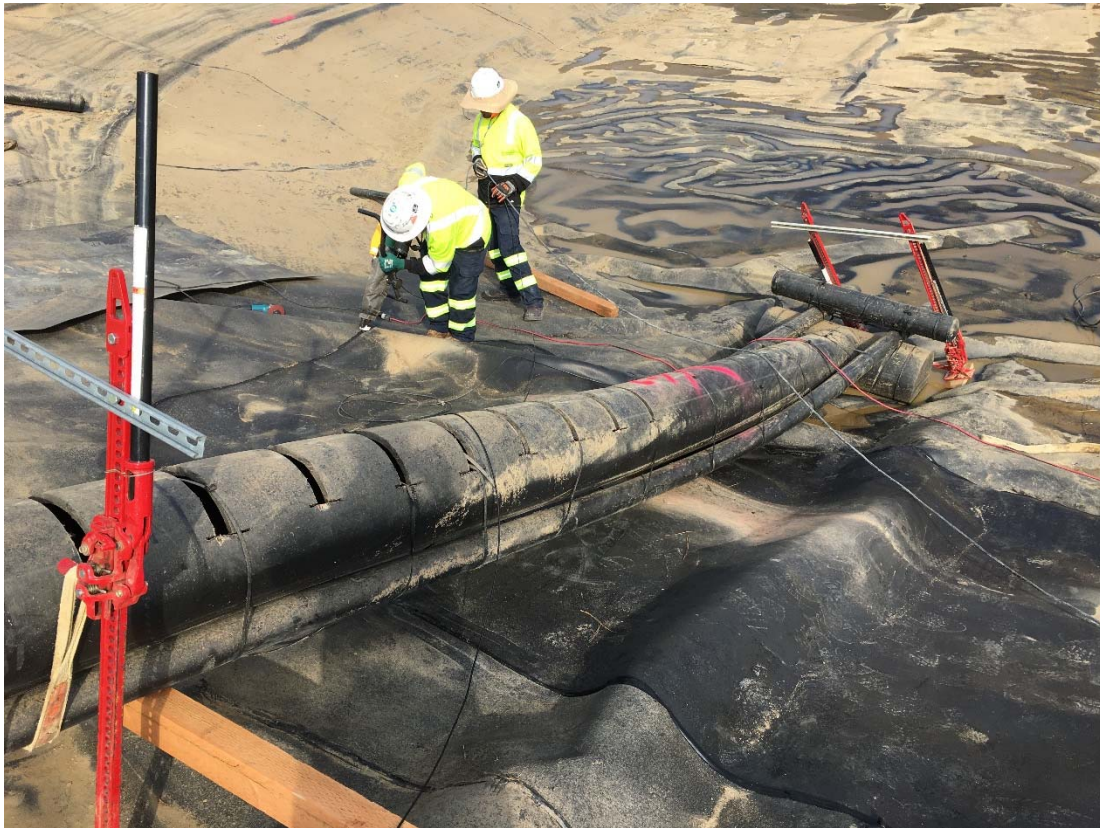
Figure 9 – Northwest Lining crew extrusion welding patch under pump riser in the west cell of the South Pond.

- Northwest Linings installed four patches on the primary liner in the west cell of the South Pond on 1 July. Newmont began transferring water from the east cell to the west cell following installation of the patches.

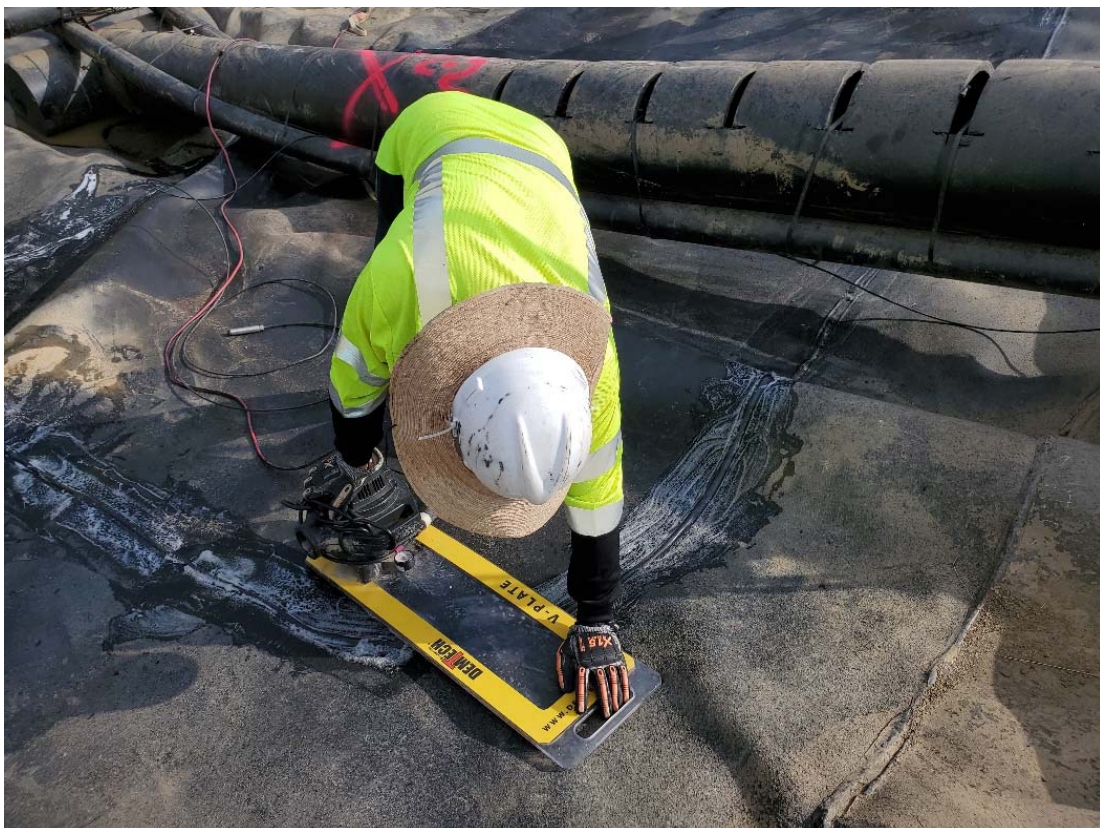
Figure 10 – Northwest Linings vacuum box testing the patch placed under the riser pipe.

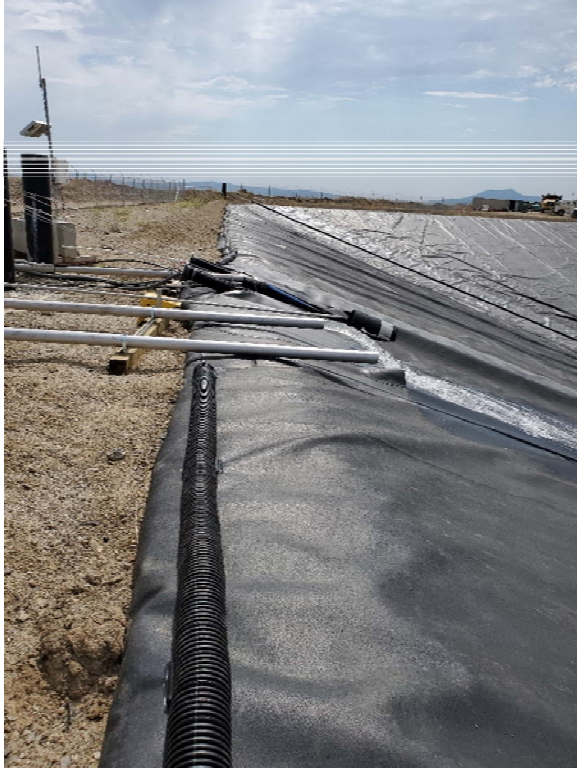
Figure 11 – Half-pipe curbs installed at the South Pond crest.

- Northwest Linings installed half pipe “curbs” along the crest of the ponds to each side of the riser pipes. The curbs are intended to reduce the amount of soil and rock from the berm from entering the pond.
